2.0 INSPECTION OF STRUCTURES

This section contains Inspection Reports for the existing structures which do not impede navigation and which are owned by the canal authority. These reports only apply to structures located in Halton and Warrington, as specified in the Brief.

Canal Lock Inspection Report

Structure Name: *Winwick Lock*

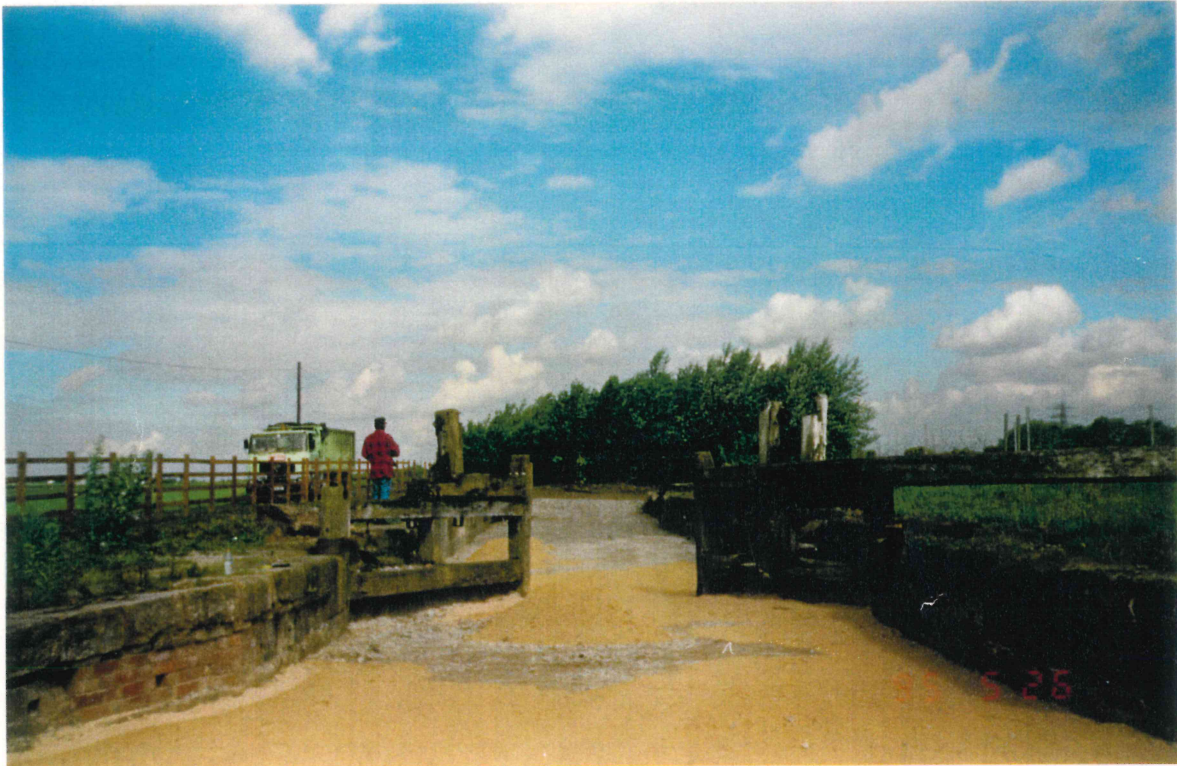
General Arrangement Photograph - Number 6/5

This lock has been infilled and is no longer in use. At either end of the chamber the canal has also been infilled. All of the lock gates are in place but are dilapidated and inoperable. Adjacent to the east chamber wall there is a concrete bywash channel.

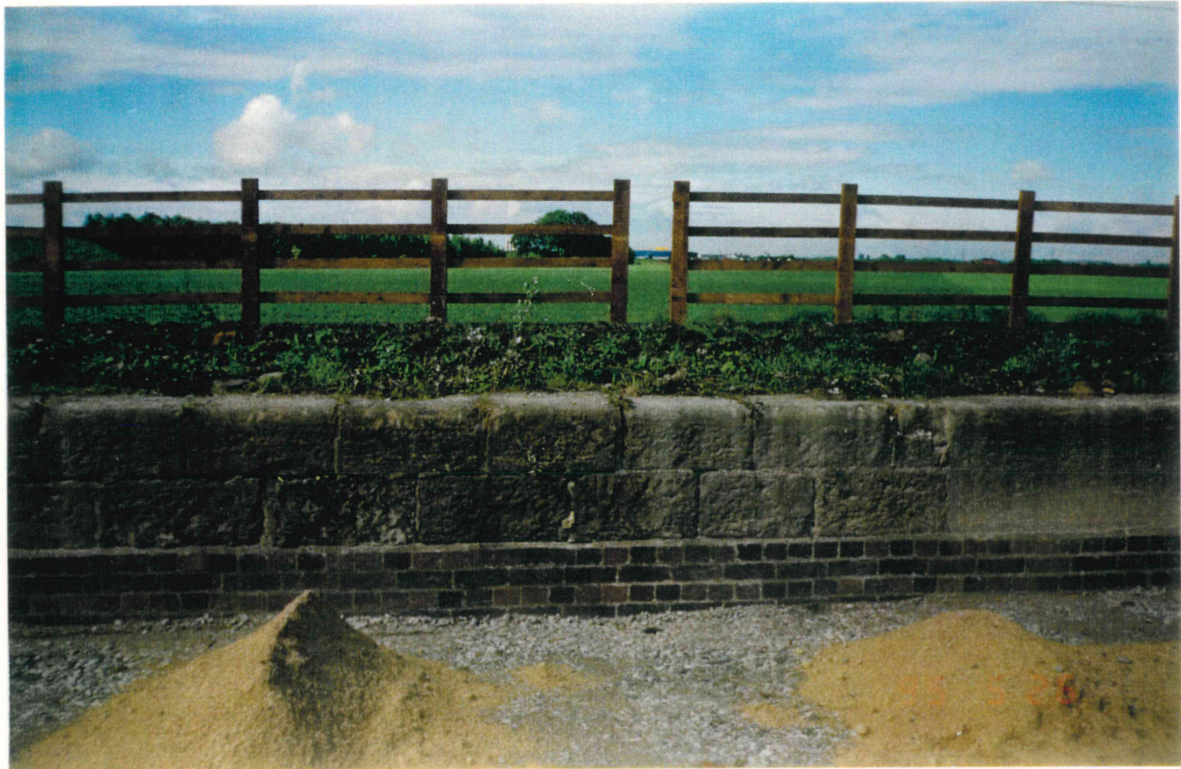
PHOTOGRAPH 6/4 - West Chamber Wall

Part No	Name of Part	1-5 P-G	Condition Report	Photo Ref.
1	Chamber Walls	2	The chamber walls are visible down to 1m below coping level. There are areas of brick infill but the walls are generally in reasonable condition.	6/4
2	Chamber Copings	3	The original masonry copings on the west wall are in good condition. On the east wall the masonry coping has been replaced with concrete.	6/4
3	Chamber Invert		Not visible for inspection.	
4	Lock Gate Sills		Not visible for inspection.	
5	Upstream Lock Gate	1	The lock gates are in very poor condition.	
6	Downstream Lock Gate	1	The lock gates are in very poor condition.	6/3
7	Upstream Lock Gate Sluices			
8	Downstream Lock Gate Sluices			
9	Ladders		There are no ladders in the chamber.	
10	Stop Plank Grooves		None provided.	
11	Chamber Wall Sluices			
12	Bywash Channel	3	The concrete channel is in reasonable condition. There are several small voids in the channel walls.	6/1

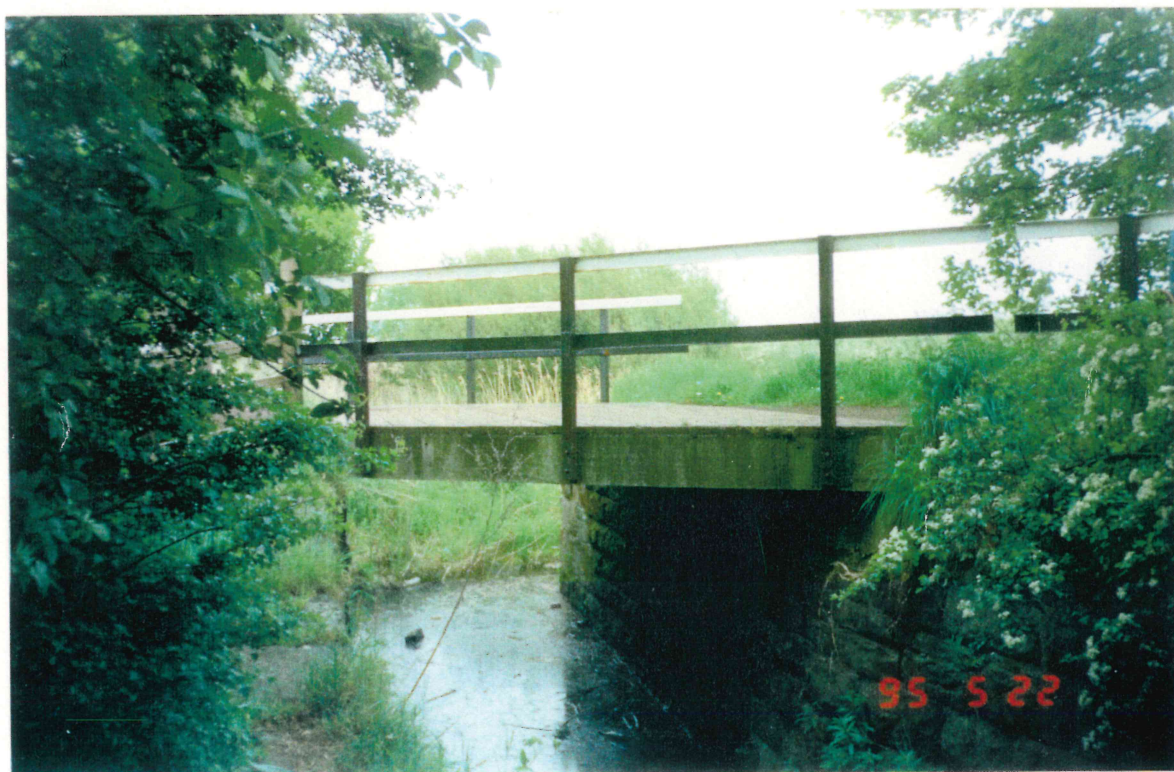
General Elevation Photograph - Number 3/21

Part No	Name of Part	1-5 P-G	Condition Report	Photo Ref.
1	Invert	1	The drainage ditch is overgrown with vegetation and the water is stagnant.	3/21
2	Aprons			
3	Foundation/Scour		Not visible for inspection.	
4	Cutwaters			
5	Piers/Columns			
6	Abutments & Bankseats	3	The masonry abutments are in reasonable condition.	3/21
7	Wingwalls			
8	Embankments			
9	Training Walls	3	The masonry training walls are in reasonable condition.	3/21
10	Drainage Substructure		None visible	
11	Parapets	3	The steel parapets are in reasonable condition with minor paint loss evident.	3/22 3/21
12	Bearings		None believed present.

Part No	Name of Part	1-5 P-G	Condition Report	Photo Ref.
13	Expansion Joints		None provided.	
14	Main Beams		The beams appear to be in good condition.	
15	Painting	3	Minor paint loss to parapets (See Section 11).	3/21
16	Troughing			
17	Jack Arches			
18	Transverse Beams & Diaphragms			
19	Waterproofing		None provided.	
20	Superstructure Drainage		None provided.	
21	Concrete Deck			
22	Arch Springing			
23	Arch Ring			
24	Voussoirs/Arch Face

Part No	Name of Part	1-5 P-G	Condition Report	Photo Ref.
25	Spandrel Walls			
26	Tie Rods			
27	Pointing	3	The pointing to the masonry walls is in reasonable condition with only minor mortar loss evident.	3/21
28	Condition of Masonry	3	The substructure masonry is in reasonable condition.	3/21
29	Surfacing	4.5	The timber decking is in good condition.	3/22
30	Footways			
31	Towpath		This is in good condition.	3/22
32	Stop Plank Grooves			
33	Canal Banks			
34	Swing Bridge Pintle			
35	Tail Rails & Wheels			
36	Hydraulics			
37	Swing Bridge Counterweights			
38	Swing Bridge Buffer

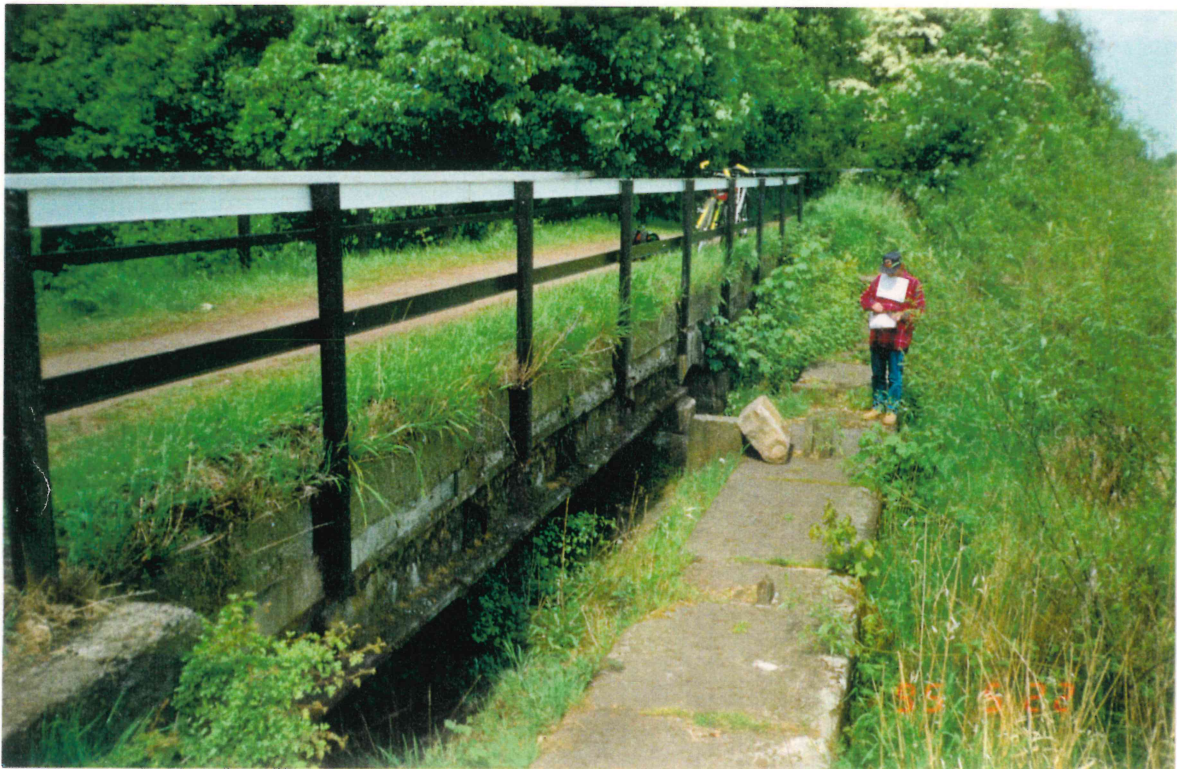
General Arrangement Photograph - Number 3/19

Part No	Name of Part	1-5 P-G	Condition Report	Photo Ref.
1	Embankments			
2	Parapets	4	The steel parapets are in good condition and appear to be fastened to the concrete slab.	3/19
3	Culvert Aprons			
4	Culvert Invert			
5	Wingwalls or Training Walls			
6	Culvert Lining			
7	Weir/Outfall Apron		The apron to the weir is severely overgrown and consequently could not be inspected.	3/19
8	Weir/Outfall Sill	4	The masonry sill to the weir is in reasonable condition with moderate vegetation growth evident in areas.	3/19
9	Weir Substructure		Not visible for inspection.	
10	Pipe Bridges			
11	Causeway			
12	Sluice Gates			
13	Towpath	4	The towpath is in good condition	
14	Sewer Pipes

Part No	Name of Part	1-5 P-G	Condition Report	Photo Ref.
15	Main Beams	1	The cast iron edge beam is in poor condition. The exposed areas of the edge beam are severely corroded. Other beams are not visible for inspection.	3/20 3/19
16	Arch Structure	1	The masonry arch is in poor condition with severe mortar loss evident.	
17	Concrete Deck	1	The exposed areas of the concrete deck are in poor condition with large areas spalling.	3/20
18	Waterproofing		Not exposed for inspection.

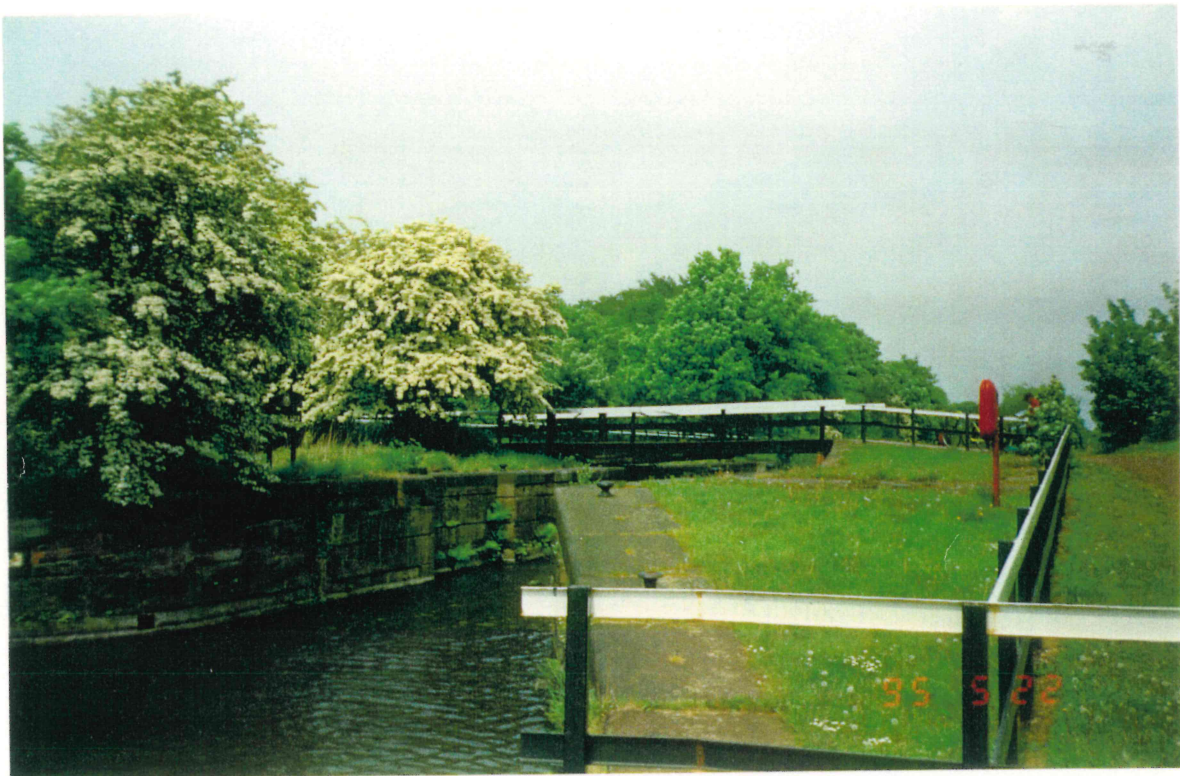
General Arrangement Photograph - Number 3/14

The lock is no longer in use. The original chamber walls are visible from coping level to a depth of 2.1m. Upstream and downstream lock gates have been removed and the sills are not visible due to the water level. There is a temporary bridge spanning the lock chamber which carries the towpath across the chamber (Structure Ref K4A).

Part No	Name of Part	1-5 P-G	Condition Report	Photo Ref.
13	Bywash Weir		See Section 12.	
14	Upstream Approach	1	The canal upstream of the lock is heavily overgrown and is no longer open to navigation.	
15	Downstream Approach	3	The downstream approach is free from debris but the channel depth is not known.	
16	Parapets	4	The steel post and two rail parapets located between the towpath and the lock chamber are in good condition.	3/14 3/17
17	Towpath			
18	Condition of Masonry	2	See Section 2.	
19	Pointing	2	See Section 2.

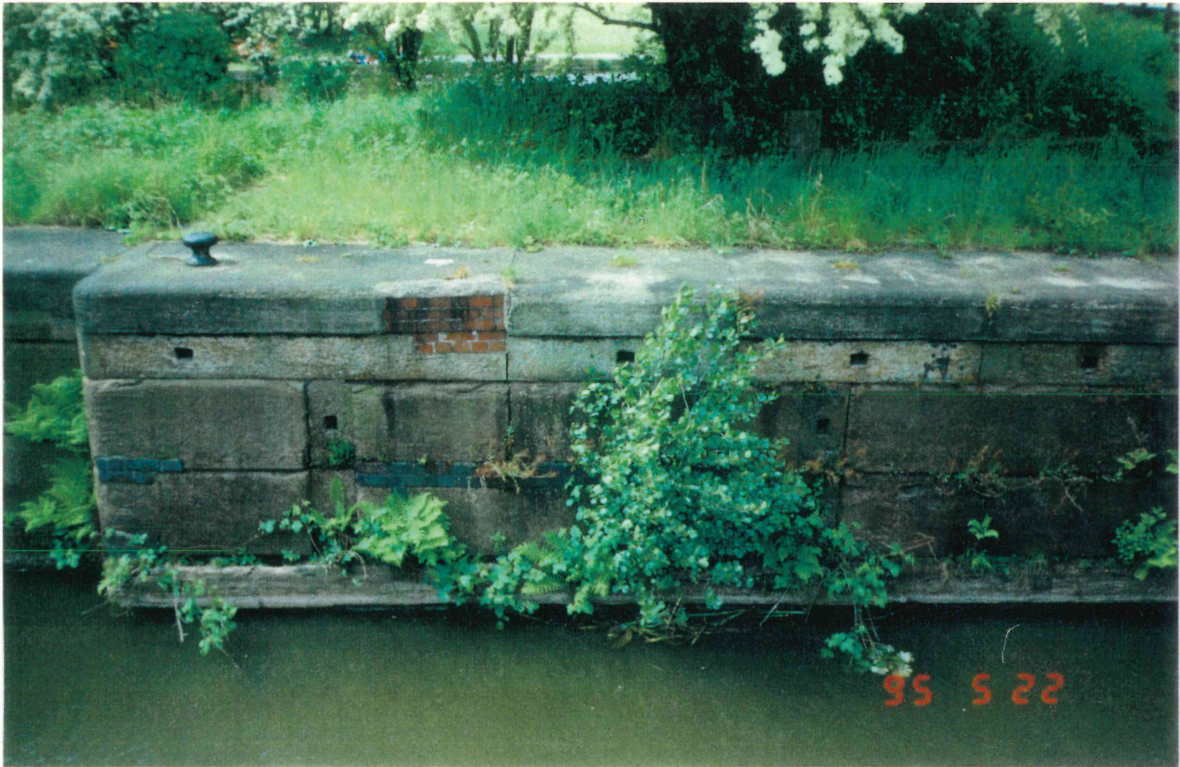
PHOTOGRAPH 3/16 - West Chamber Wall

Part No	Name of Part	1-5 P-G	Condition Report	Photo Ref.
1	Chamber Walls	2	There is heavy vegetation growth between masonry courses and isolated areas of brick infill and sections of timber attached to the masonry.	3/16
2	Chamber Copings	4.5	The original masonry copings are generally in good condition.	3/16 3/17
3	Chamber Invert		Not visible for inspection due to the water level.	
4	Lock Gate Sills		Not visible for inspection due to the water level.	
5	Upstream Lock Gate		The lock gates are missing.	3/17
6	Downstream Lock Gate		The lock gates are missing.	3/17
7	Upstream Lock Gate Sluices		See Section 5.	
8	Downstream Lock Gate Sluices		See Section 6.	
9	Ladders		The ladders to the chamber are missing.	
10	Stop Plank Grooves	3	The stop plank grooves are partially infilled with timber and vegetation.	
11	Chamber Wall Sluices		None visible.	
12	Bywash Channel		Bywash facilities are provided by the nearby overflow weir (Structure Ref. K3).

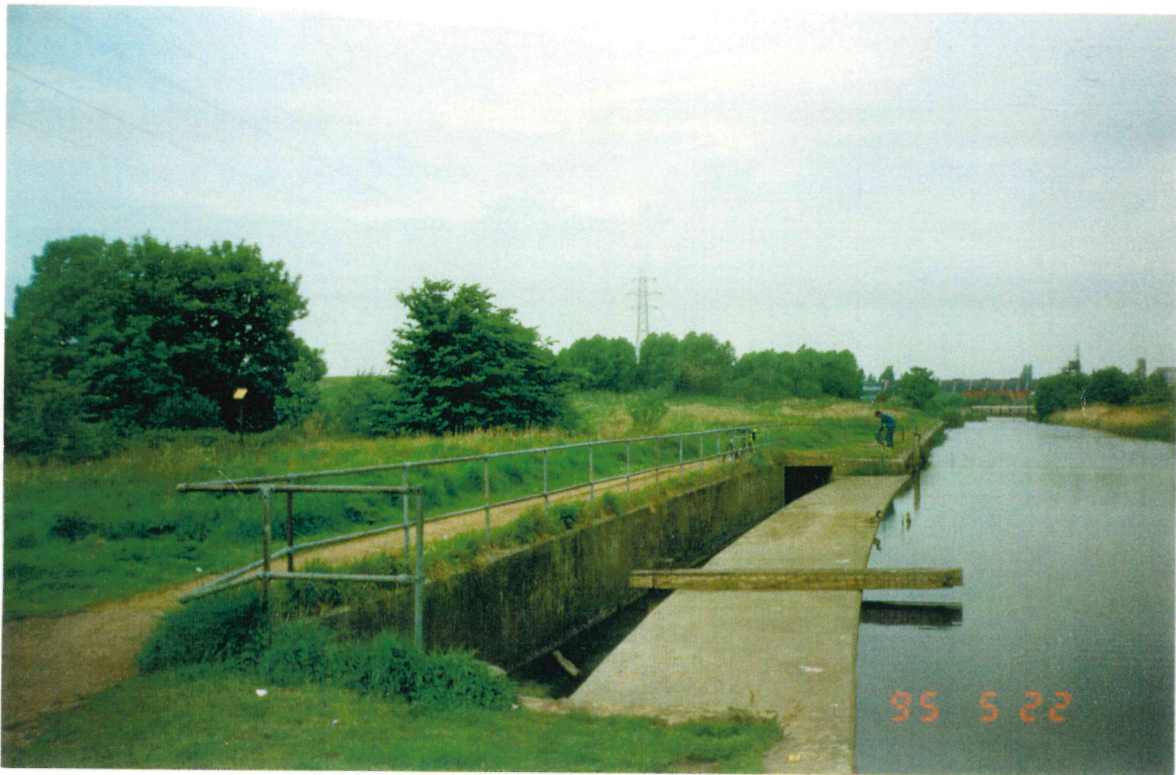
General Arrangement Photograph - Number 2/11

Part No	Name of Part	1-5 P-G	Condition Report	Photo Ref.
1	Embankments			
2	Parapets		The bottom rail of the parapet is damaged at the east end. There is minor corrosion to the steelwork.	2/11 2/12
3	Culvert Aprons			
4	Culvert Invert			
5	Wingwalls or Training Walls	5	The culvert training walls are in good condition.	2/13
6	Culvert Lining			
7	Weir/Outfall Apron		Not visible for inspection.	
8	Weir/Outfall Sill	4.5	The sill is in good condition with minor vegetation growth at the west end.	2/12
9	Weir Substructure	5	The concrete channel is in good condition with only minor debris evident.	2/12
10	Pipe Bridges			
11	Causeway			
12	Sluice Gates	3	The sluice gate, which is west of the overflow, is in reasonable condition although there is minor leakage evident.	2/12
13	Towpath		This is in good condition.	
14	Sewer Pipes

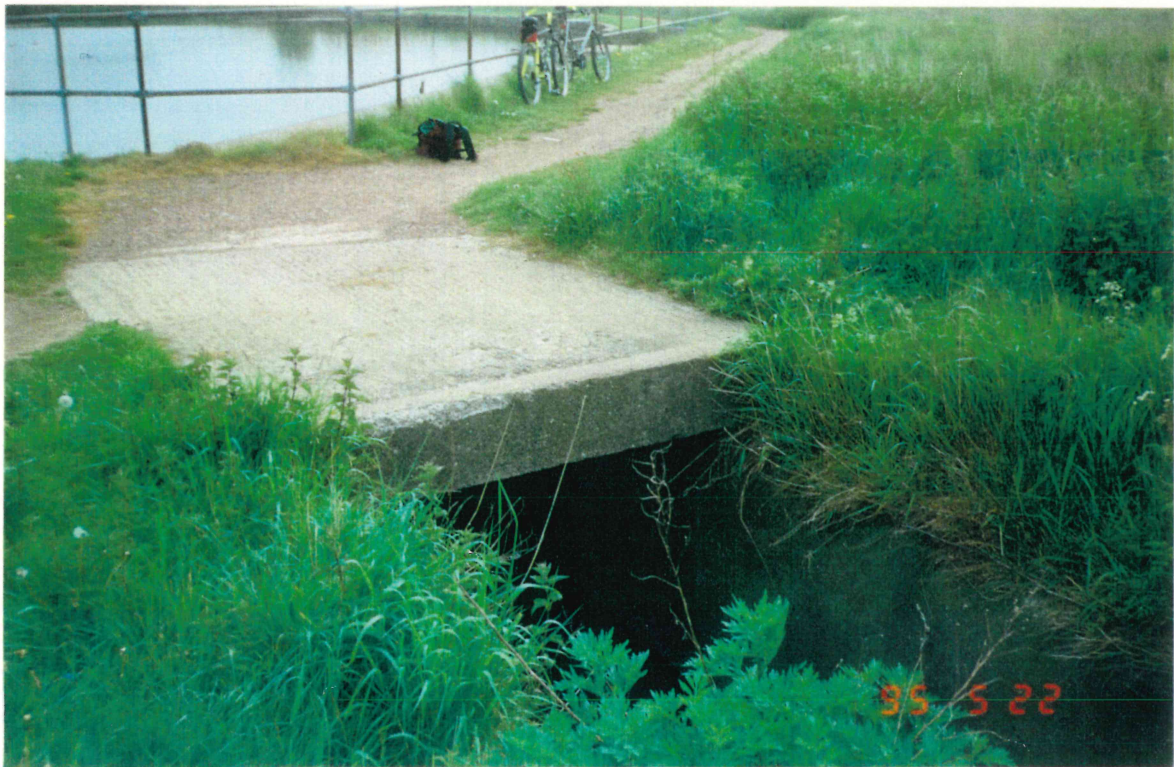
PHOTOGRAPH 2/13 - Concrete Slab Bridge

Part No	Name of Part	1-5 P-G	Condition Report	Photo Ref.
15	Concrete Slab/Bridge	4	This is in good condition with only minor spalling to the South edge.	2/13

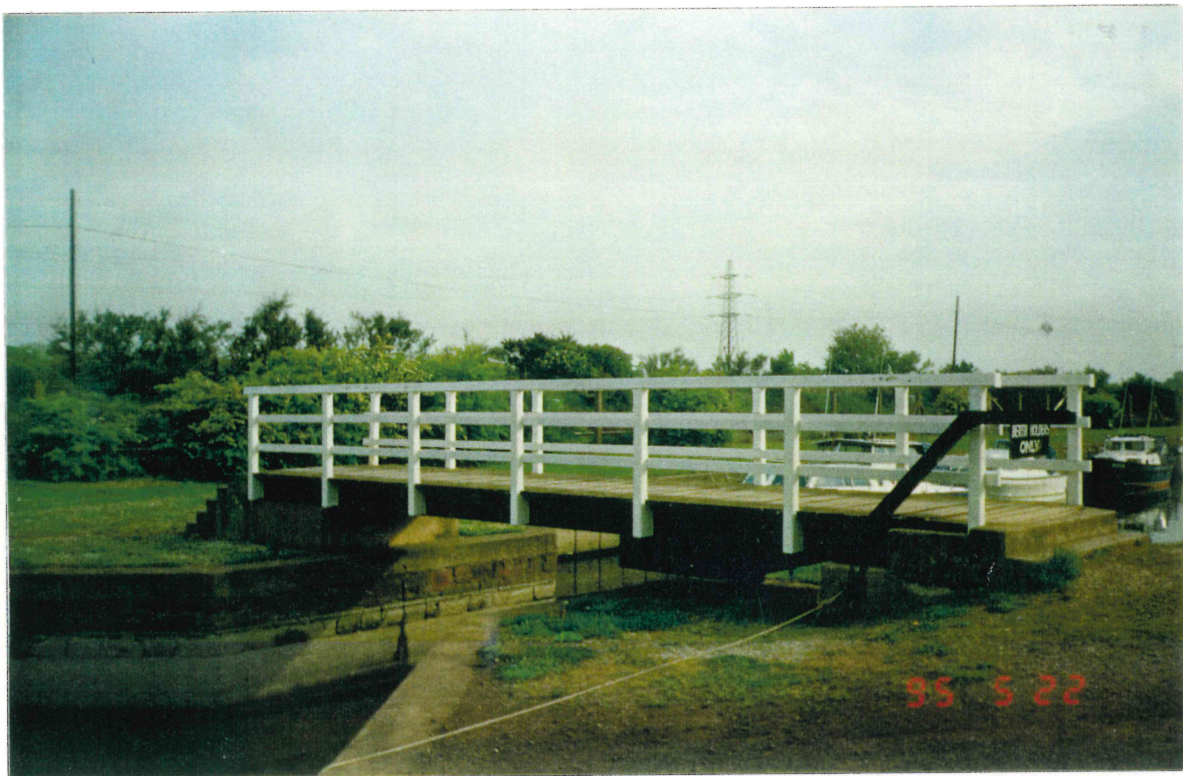
General Elevation Photograph - Number 1/33

This swing bridge provides pedestrian access to the west canal bank. It comprises two longitudinal steel beams with four steel cross beams and timber decking. The substructure consists of reinforced concrete abutments which have steps formed in them to provide access for pedestrians. The swing mechanism is located on the east bank of the canal and is operated manually.

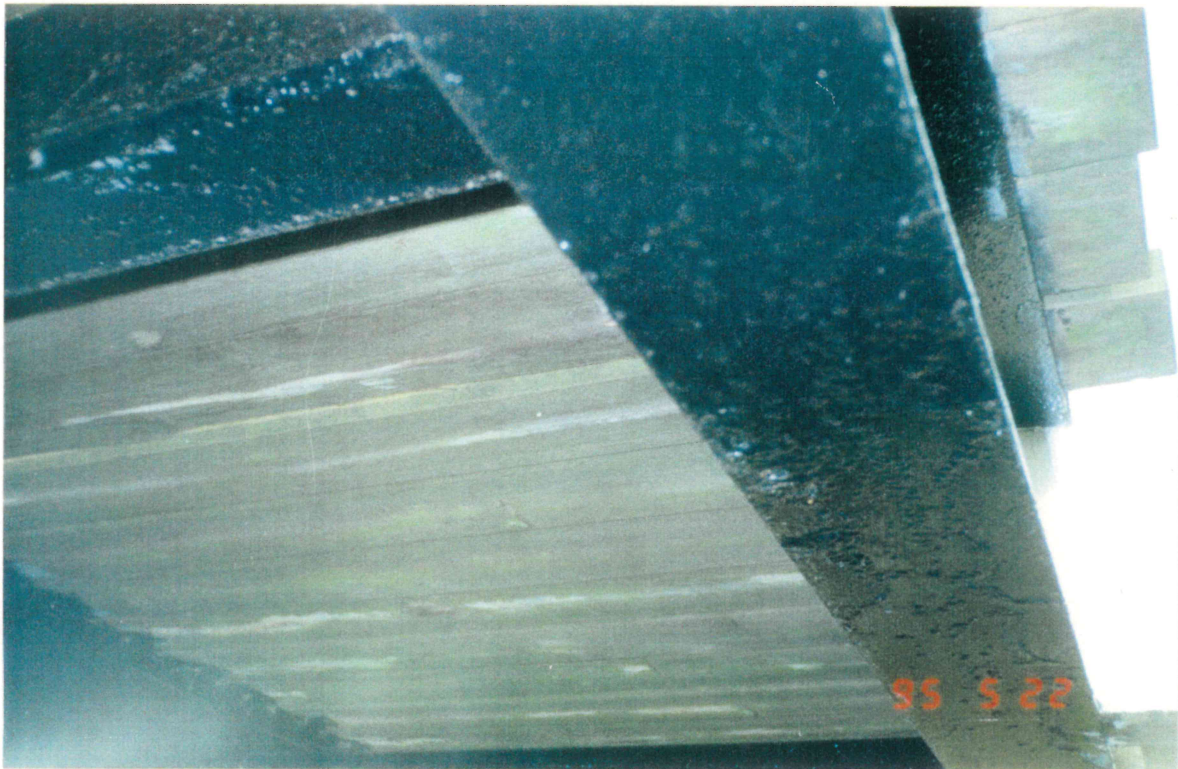
PHOTOGRAPH 1/34 - Underside of the Bridge Deck

Part No	Name of Part	1-5 P-G	Condition Report	Photo Ref.
1	Invert		The canal invert is free from debris but the channel depth was not established.	
2	Aprons			
3	Foundation/Scour		The foundations were not exposed for inspection.	
4	Cutwaters			
5	Piers/Columns			
6	Abutments & Bankseats	5	The concrete abutments are in good condition.	1/33
7	Wingwalls			
8	Embankments			
9	Training Walls			
10	Drainage Substructure		None visible.	
11	Parapets	5	The steel parapet is in good condition with no paint loss evident.	1/34
12	Bearings	5	The west abutment bearings are in good condition.	2/6

Part No	Name of Part	1-5 P-G	Condition Report	Photo Ref.
13	Expansion Joints		Not applicable.	
14	Main Beams	5	The main beams are in good condition.	1/34
15	Painting	5	See Sections 11 and 14.	
16	Troughing			
17	Jack Arches			
18	Transverse Beams & Diaphragms	5	The transverse beams are in good condition.	1/34
19	Waterproofing		None provided.	
20	Superstructure Drainage		None provided.	
21	Concrete Deck			
22	Arch Springing			
23	Arch Ring			
24	Voussoirs/Arch Face
